Manhole Inspection Summary

Manhole # S07SS_002MH

Insp Date: **6/27/08 1:26 PM**

Location Address: **3403 DUVALL AVE**

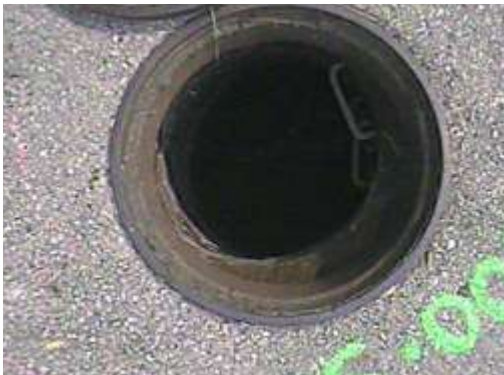
Defect 4

Frame Offset: **3** (in.) Condition: ☒ Sound ☐ Cracked ☐ Leaks

FRAME OFFSET

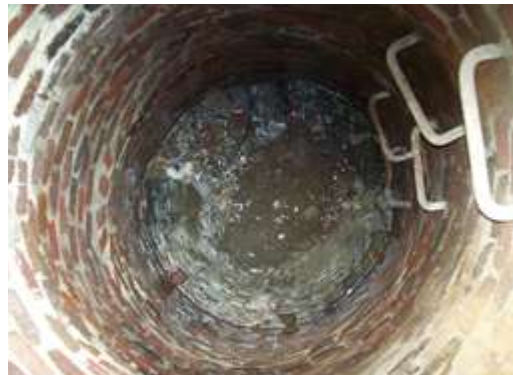
Defect 5

Condition: ☐ Sound ☐ Cracked ☐ Root Intrusion ☐ Deteriorated ☐ Leaks ☒ **Debris**

DEBRIS ON BENCH

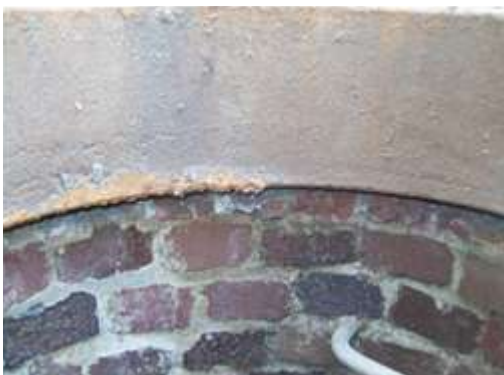
Defect 3

Condition: ☐ Sound ☒ **Cracked** ☐ Root Intrusion ☒ **Loose Brick** ☐ Deteriorated

CRACKED FRAME ADJUSTMENT

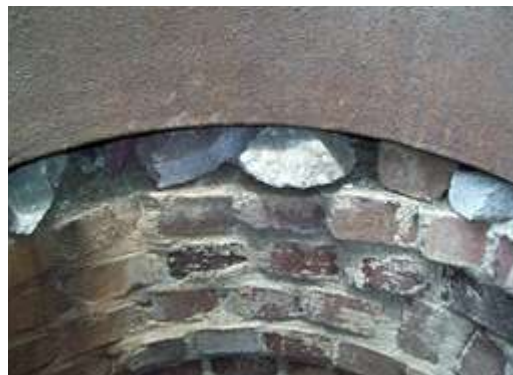
Defect 1

CHIMNEY LOOSE BRICKS

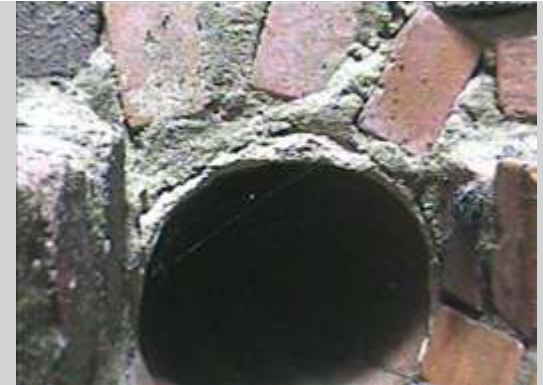
12 O'Clock Outflow

8 in. Circular Gravity Sewer
Pipe Out @ 12 O'Clock

Pipe Height: (in.) Direct
Pipe Material: **Clay** ☐ Pipe Lined
Invert Depth: **10.10** (ft.) Flow Characteristics: **Slow**
Deposits: ☒ None ☐ Mud ☐ Sludge ☐ Debris ☐ Grease
Silt Depth: (in.) Deposits Extent:
Infiltration: **None** Pipe Seal Cond: **Cracked**

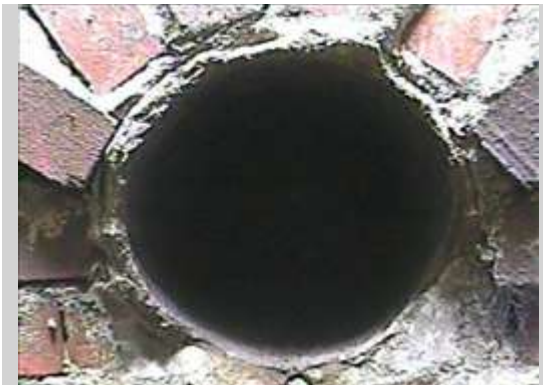
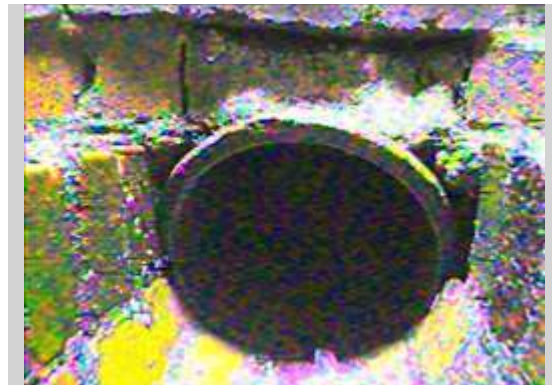
9 O'Clock Inflow

8 in. Circular Gravity Sewer
Pipe In @ 9 O'Clock

Pipe Height: (in.) Direct
Pipe Material: **Clay** ☐ Pipe Lined
Invert Depth: **6.95** (ft.) Flow Characteristics: **Slow**
Deposits: ☒ None ☐ Mud ☐ Sludge ☐ Debris ☐ Grease
Silt Depth: (in.) Deposits Extent:
Infiltration: **None** Pipe Seal Cond: **Cracked**

Drop: **Outside Direct**
Angled: Reading: (ft.)
Inv Depth: **10.00** (ft.)

Drop Condition: **Open**
